# 5 Performance of Buildings in Houston's Central Business District

*Although Hurricane Ike's winds were not as high as the current design wind speed, some buildings received extensive exterior envelope damage.*

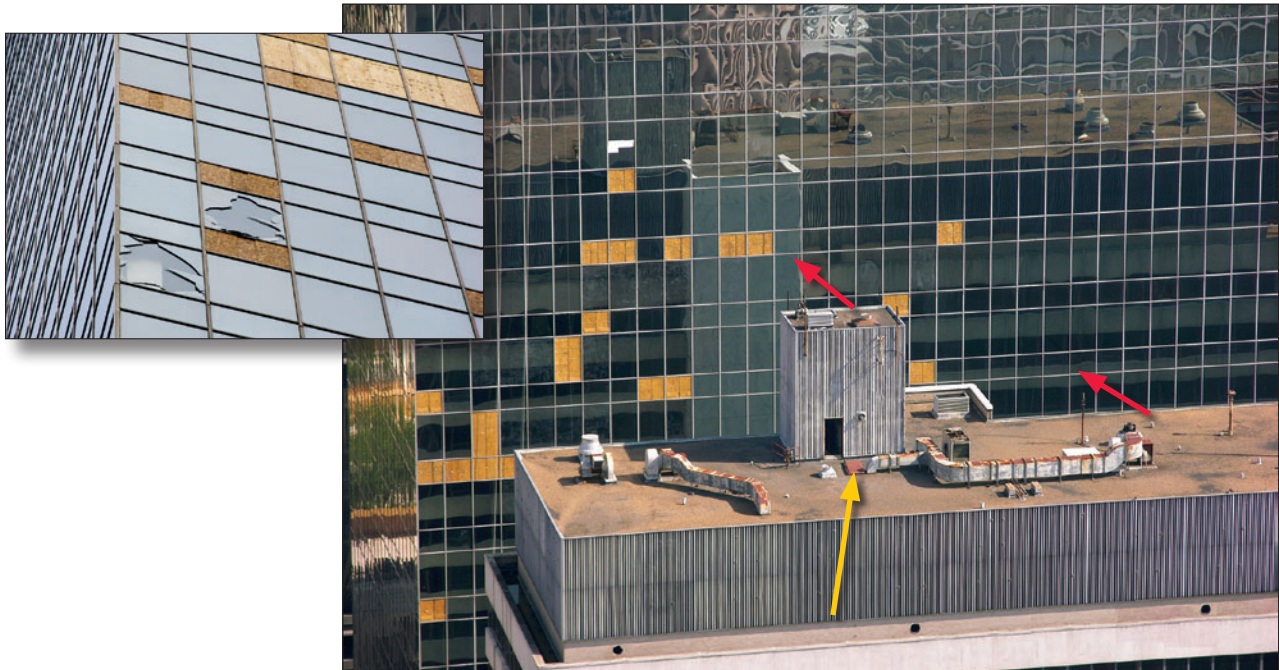
**Figure 5-26.**  
View of the aggregate-surfaced roofs on building B-5 and broken glazing on building B-4 beyond. Red arrows indicate generalized aggregate flight path. The yellow arrow shows a penthouse door that blew off. Inset shows damage on a portion of building B-4 below the area shown in the main photograph.

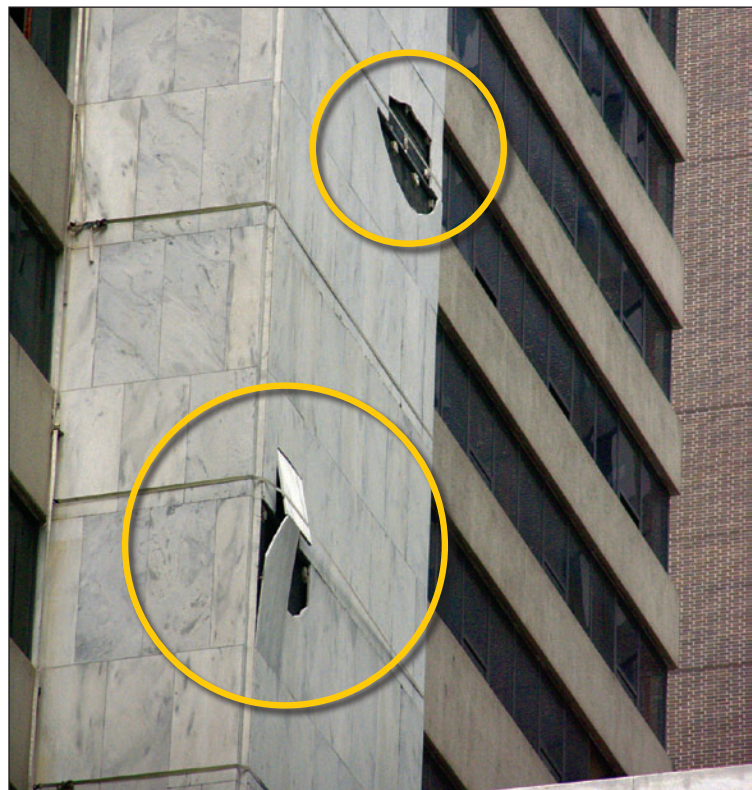
**Figure 5-27.**  
Stone veneer damage on backside of building B-5 (side facing B-4)

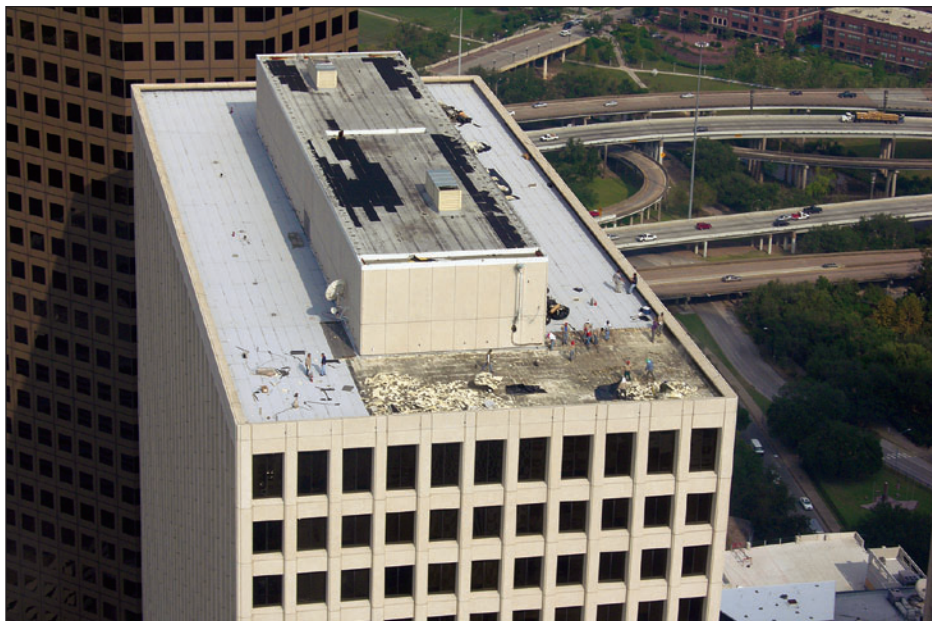
Figure 5-28 shows roof covering damage to building B-1, which was a possible debris source for some of the glazing damage to Chevron Center, as discussed in Section 5.3.1. This building is one of the oldest high-rise buildings in the downtown area.

Figure 5-28.  
Roof covering damage on  
the main and penthouse  
roofs of building B-1
